# Traditional Buildings: why we must treat them differently

Rheged, Wednesday 30th March 2011

Alan Gardner

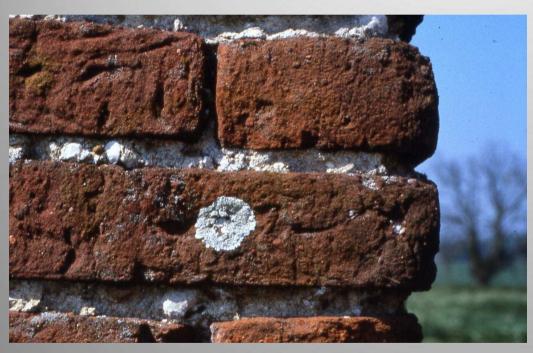
## The Breathing Performance: mortars

- 80% evaporation through the joint zone
- Moisture concentration = accelerated decay through freeze thaw and salt activity.
- Rate of decay?
- Ability to accommodate movement (autogenous properties)

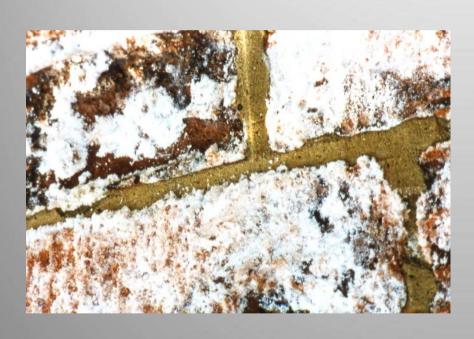
#### Salt Damage/Naming of Parts

- Wetting and drying cycles and the presence of soluble salts creates a build up of pressure
- Particularly damaging to masonry of uniformly distributed fine pores (microporous stone)
- Excessive use of water mobilises embedded salts
- Hygroscopic salts increases 'air dry' or natural content (relate to free or capillary moisture)

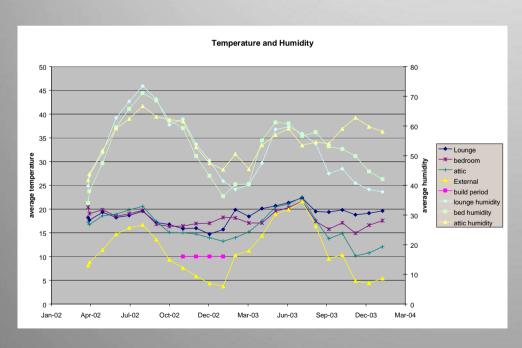
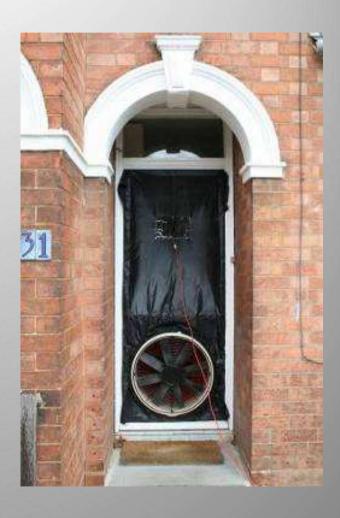
#### Thermal performance/performance in use

Data Logging
Fuel bills
Fan pressurisation
tests
