## Case Study: Chorlton High School

SuDS Audit – March 2016

## Site Audit Findings – see Appendix 2 for the location of potential SuDS

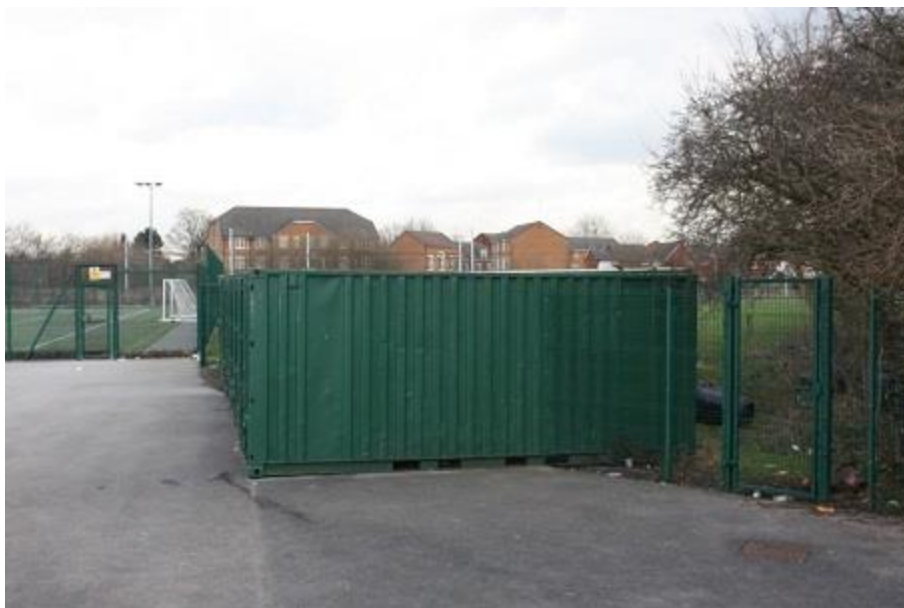
**Figure 1 – Freight Containers**

**Map Reference A** – Seven freight storage containers on grass adjacent to asphalt sports pitch / artificial sports pitch. The freight containers could, subject to loading, host extensive green roof systems.

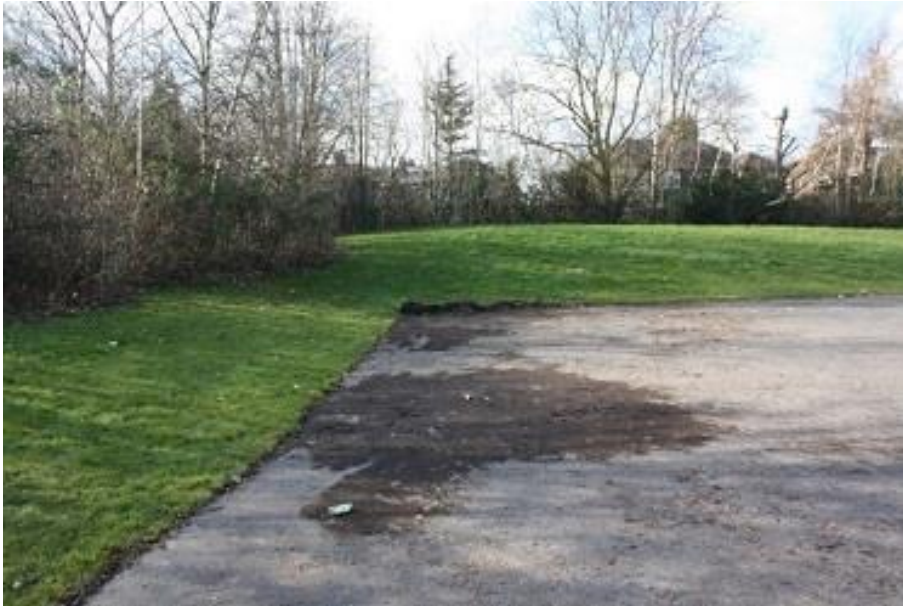
**Figure 2 – Silt Deposit from Run Off on Sports Pitch next to Grass Embankment**

**Map Reference B** – Base of embankment adjacent to asphalt sports pitch. The pitch slopes towards the grass embankment and there is evidence from silt deposits that water drains to this point. A filter strip could be installed at the base of the embankment along its length to intercept the runoff that accumulates here. This would be subject to subsoil conditions.

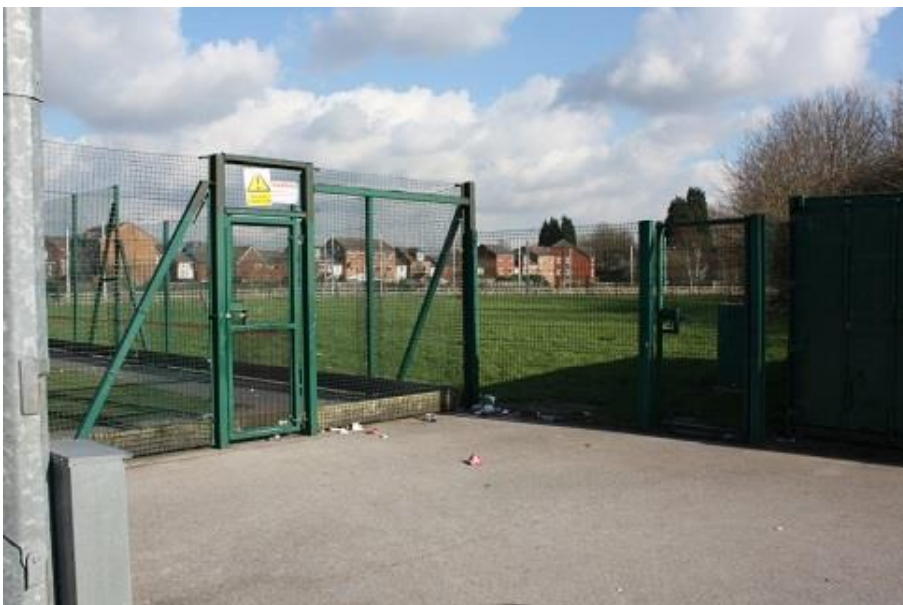
**Figure 3 – Asphalt Surface Adjacent to Freight Containers**

**Map Reference C** - Hard landscaped area after bridge in front of freight containers. There is a slight fall towards the freight containers. Surface water runoff could be shed into a bio- retention area / swale. Ground conditions would need to be established to determine whether rainwater will be able to infiltrate or moved onto the adjacent green space and then the Chorlton Brook.

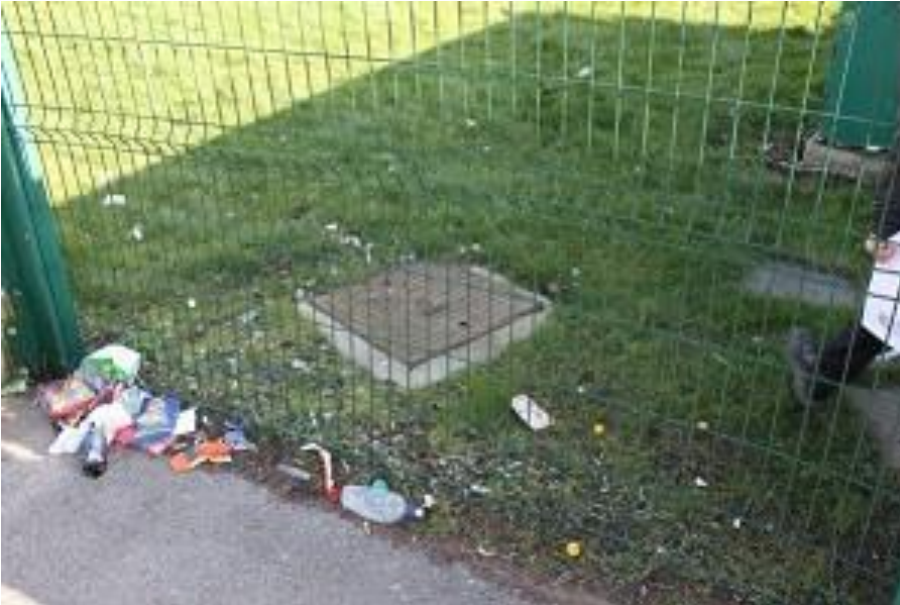
**Figure 4 – Exit Drain for Sports Pitch Runoff**

**Map Reference D** - Grassed space between AstroTurf pitches and Chorlton Brook. Rainwater draining off the sports pitches could be conveyed into a detention basin where it can be stored and allowed to infiltrate (subject to the sub-soil conditions). In significant / prolonged rainfall events, water could be conveyed to the adjacent Chorlton Brook. To facilitate this SUDS intervention a level change would be required to get the rainwater from the drain into this space.

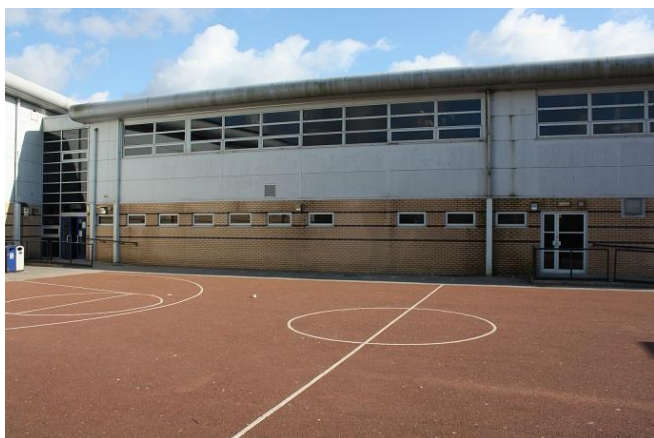
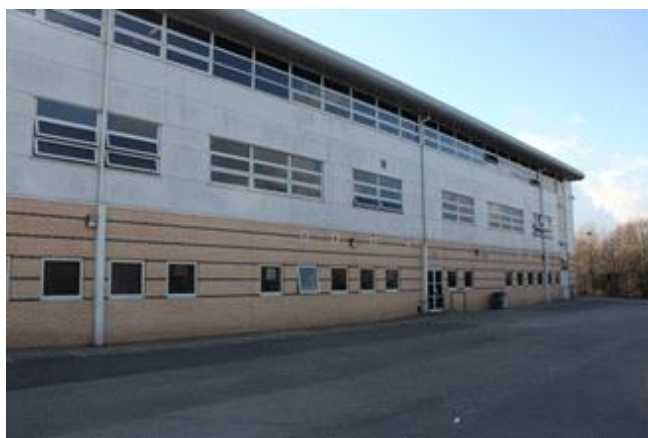
**Figure 6 / 7 – Playground areas adjacent to Main Building & Sports Hall**

**Map Reference F-** Playground adjacent to sports hall & main building. The surface channel drains on the playground frequently back up despite cleaning. Soakaways could be installed to allow water to infiltrate in substrate - depending on subsoil type

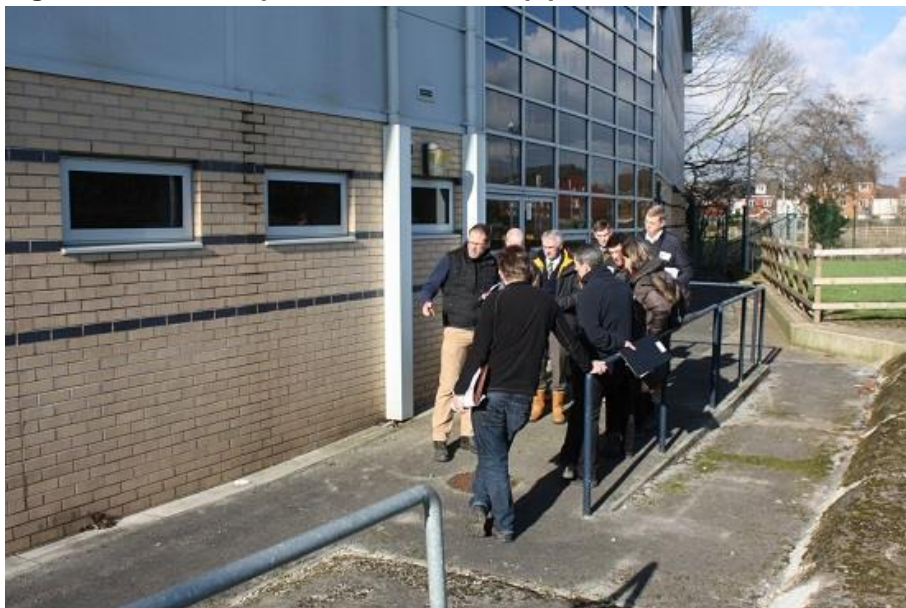
**Figure 8 – Back of Sports Hall with Downpipes Visible**

**Map Reference G/H** - Sports hall - Mauldeth Road elevation. Water draining off the Sports Hall roof via the downpipes could be diverted into downpipe planters.

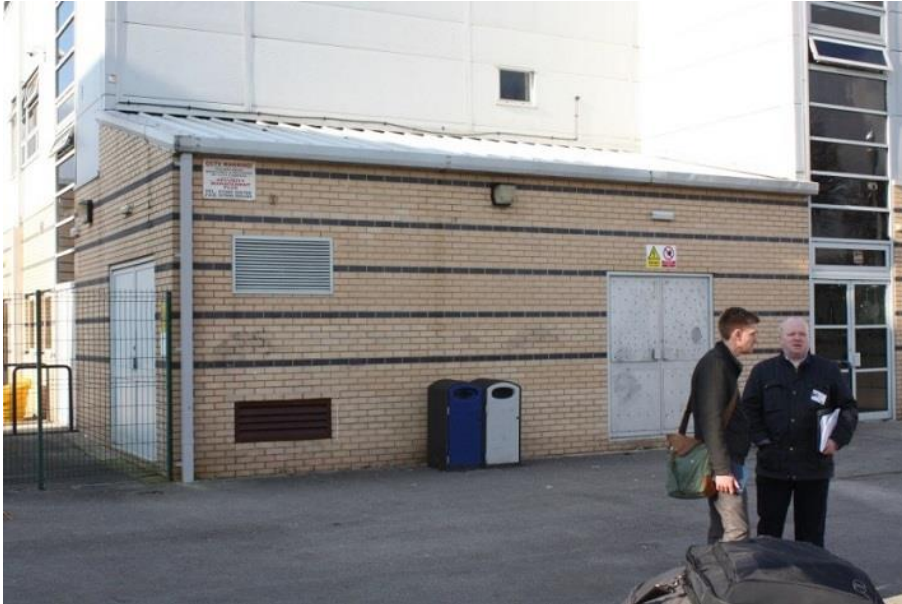
**Figure 9 – Pitched Roof On Plant Room Back of Main Building**

**Map Reference I/J** - Main Building - Mauldeth Road elevation – plant room roof. There is a potential opportunity for an extensive green roof system. The roof is pitched so box partitions may be required to prevent soil migration - structural assessment would also be needed. In addition a downpipe planter could also be installed to take the water off the roof / green roof.

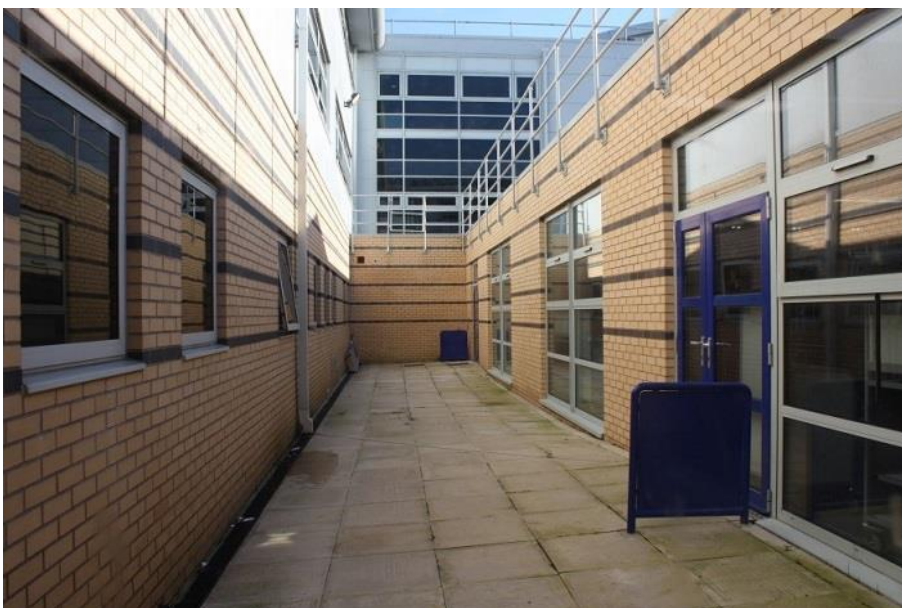
**Figure 10 – Atrium Next to Canteen**

**Map Reference L** - Atrium adjacent to canteen in the main building. Remove flags and form raingarden - diverting water from downpipe(s) into the raingarden. Further investigation would be required to determine sub soil conditions for infiltration and any potential impact on building foundations.

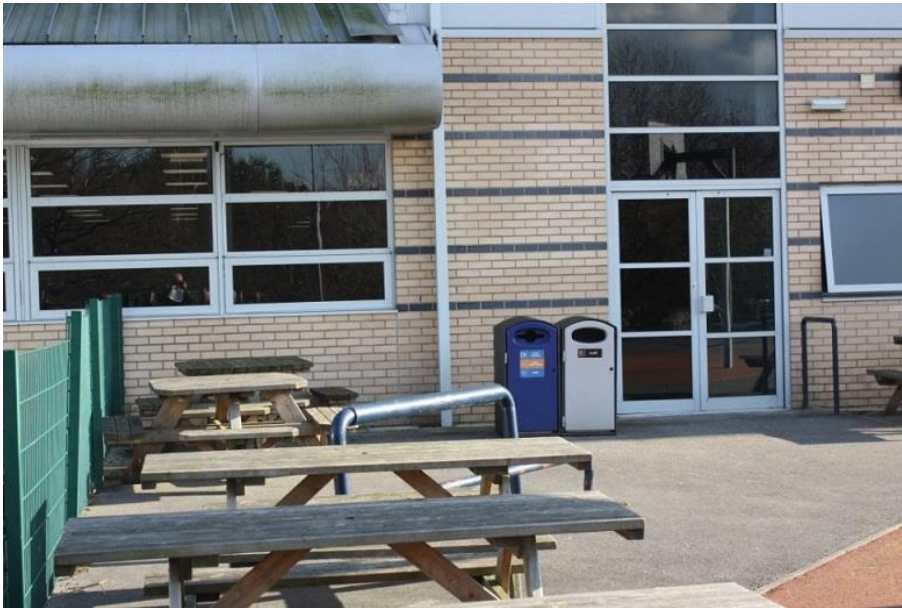
**Figure 11 – Bin Store / Picnic Table Area**

**Map Reference M/N** - Bin store and picnic table area. There is the potential to install two down pipe planters here to take water off this section of the main building roof. Some reconfiguring of the picnic tables would be required to provide sufficient space for the planters.

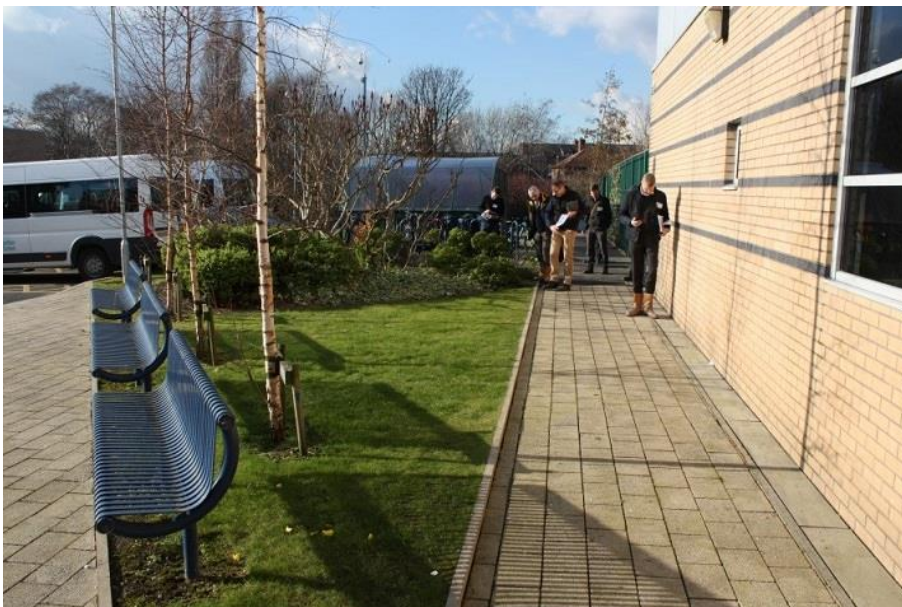
**Figure 12 – Green Space Left of Main Building Entrance, Bicycle Shed in the Background**

**Map Reference O** - Green triangle to left of main building entrance. Divert water from downpipe into existing greenspace to create a raingarden. Further investigation would be required to determine sub soil conditions for infiltration and any potential impact on building foundations.

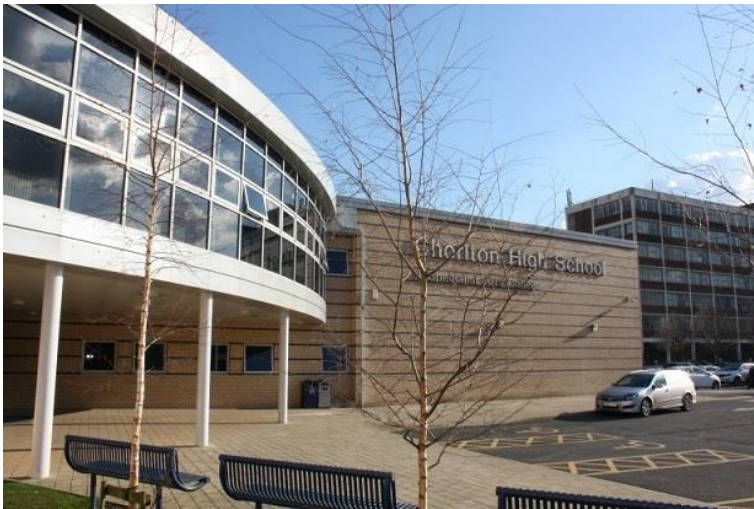
**Figure 13 – Main Building Entrance Canopy**

**Map Reference Q** - Entrance canopy roof. There is an opportunity for an extensive green roof system, subject to a structural assessment. The roof is accessible for maintenance operatives.

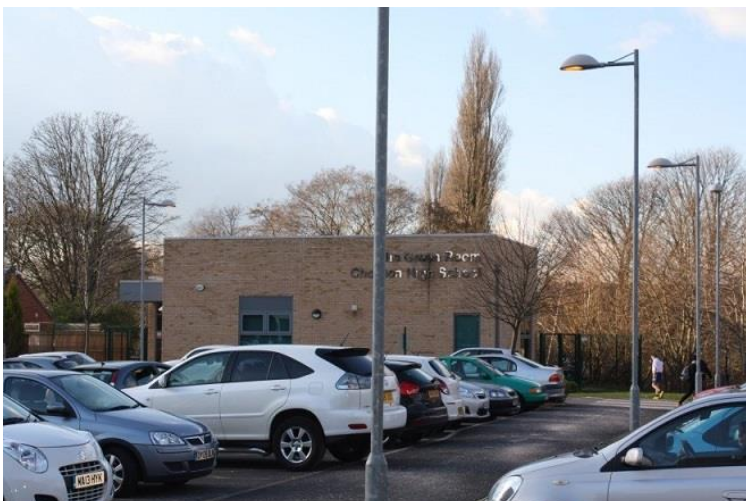
**Figure 16 – Green Room and Car Park**

**Map Reference W** - Green Room. On first visual assessment this appears to have a substantial roof that could support an extensive green roof system but structural assessment will still be required. There is also a parapet wall that appears to provide high enough protection for maintenance operatives
